REQUEST FOR PROPOSALS FOR ABATEMENT OF THE OTERO COUNTY SHERIFF'S DEPARTMENT

Project: Asbestos Abatement

Location: Otero County Sheriff's Office and Jail – Currently Vacant
222 E 2nd Street La Junta, Colorado 81050

ASBESTOS INSPECTION REPORT

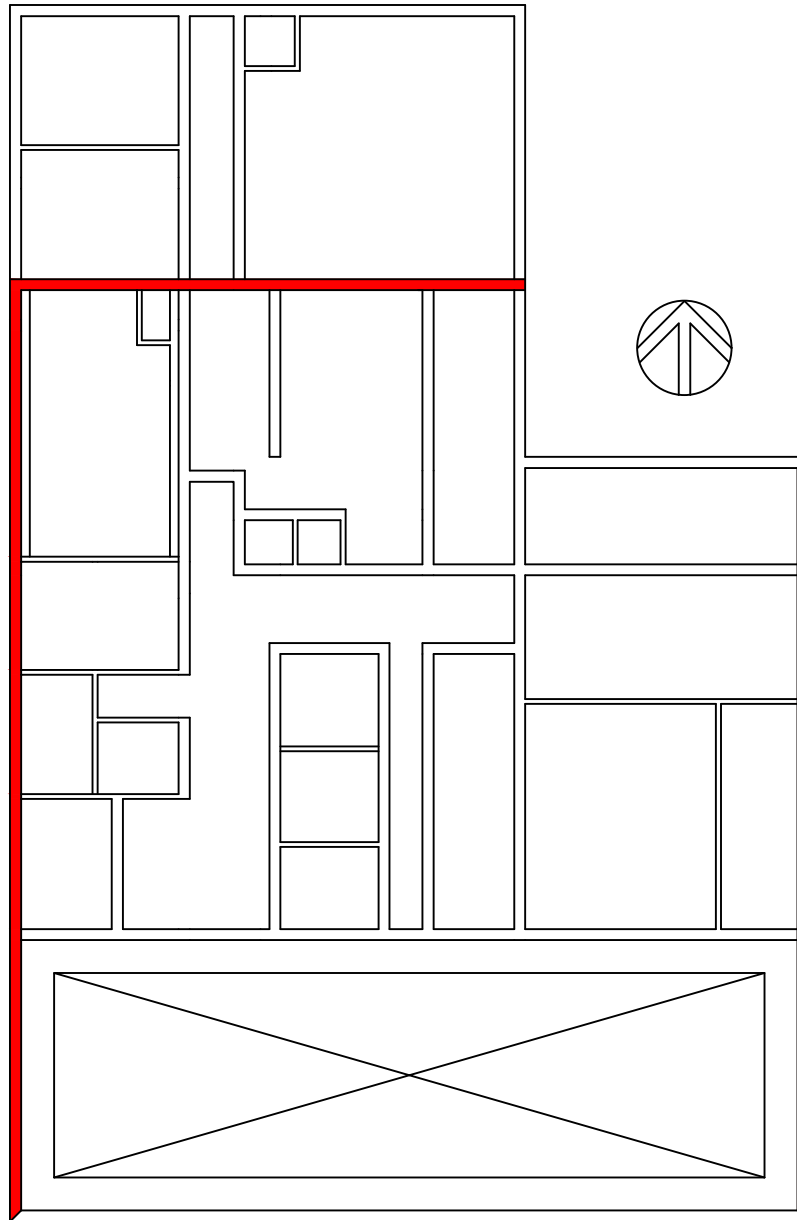
ACM location Diagram

Red = Positive ACM – Reference Appendix 4 - ACM Location Diagram

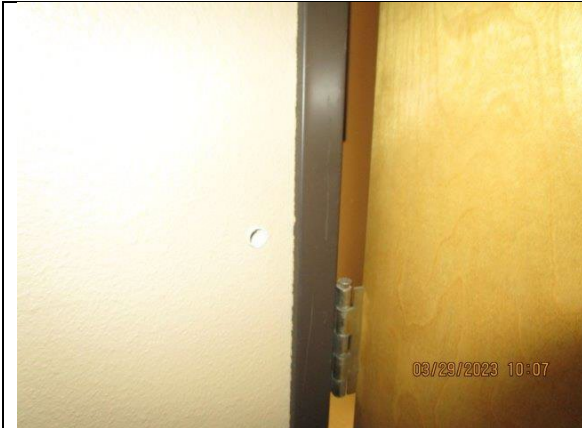
Light Orange Peel Drywall

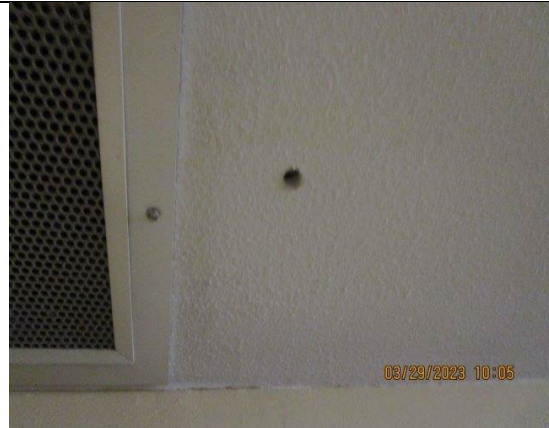
Heavy Orange Peel Drywall

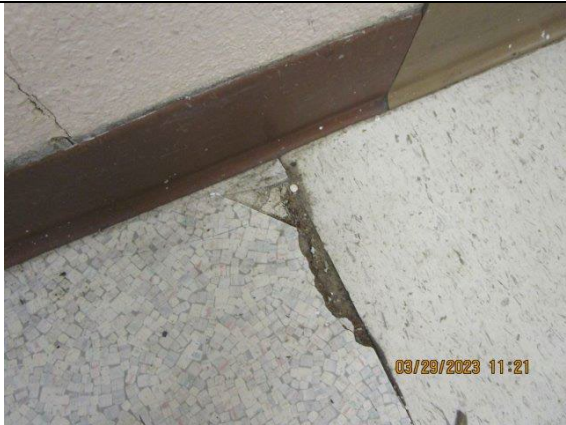
Pebble Pattern Sheet Flooring

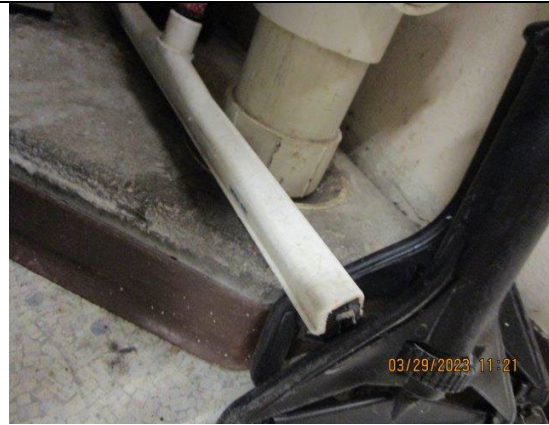
2" Brown Cove Base

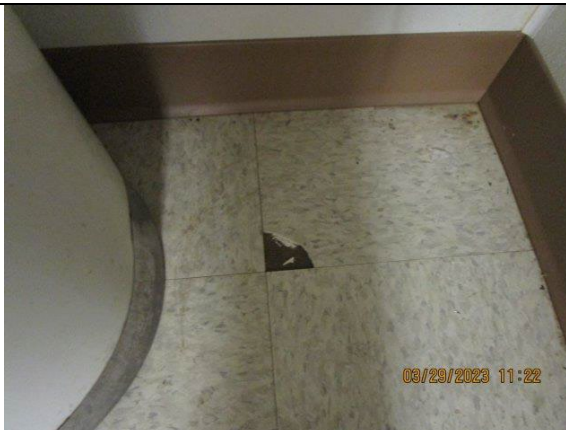
Tan/Brown 12X12 VCT

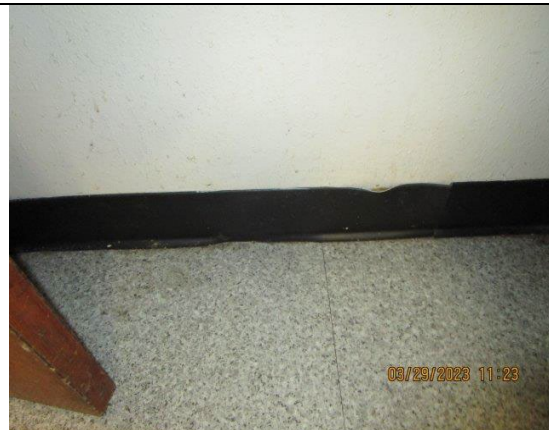
Black Cove Base

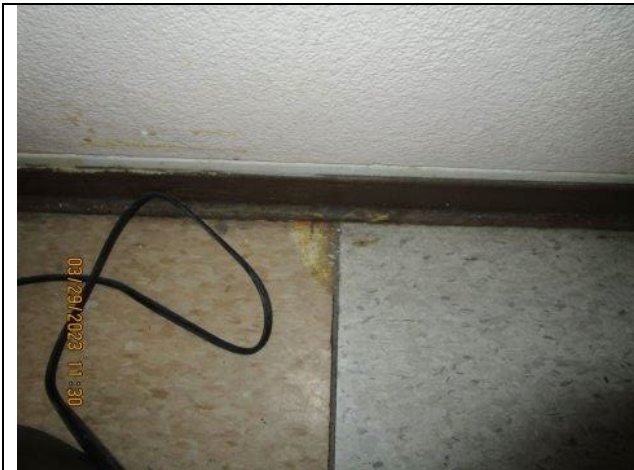
Dark Tan 12X12 VCT

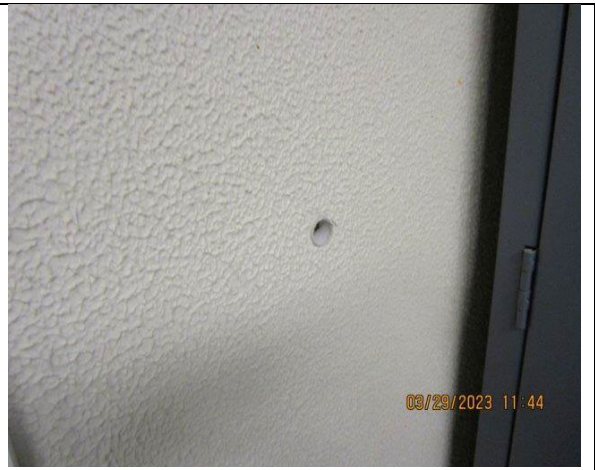
Rough Texture Drywall

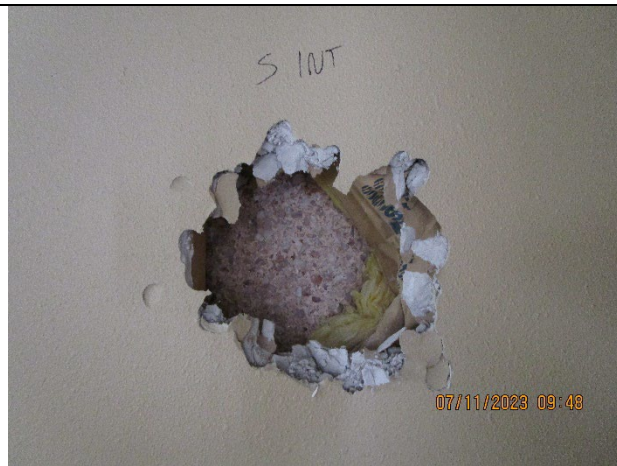
- The Siding Pink (2A – 2C) observed on walls is confirmed to be an **ACM** material by initial PLM Method:
 - ***222-2A-NA is 4% Chrysotile***
 - ***222-2B-Siding 1 is 2% Chrysotile***
 - ***222-2B-Siding 2 is 2% Chrysotile***
 - ***222-2C-Pink Siding is 4% Chrysotile***
 - 222-2C-Gray Siding is None Detect

The materials assessed were in good condition at the time of the inspection and non-friable.

Non friable in current state however will be rendered friable during demolition. This material will need to be removed prior to any demolition activities.

ACM - PINK

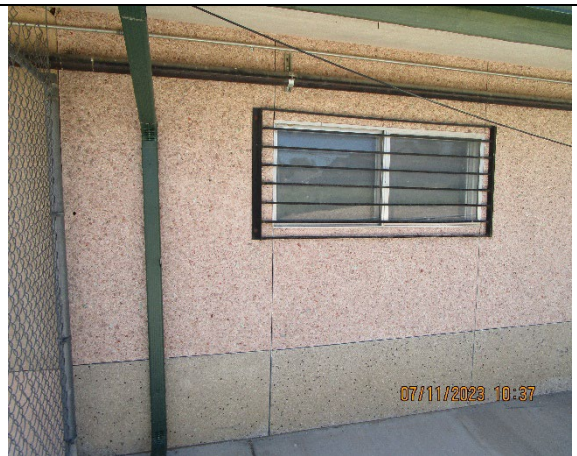
- The Siding Pink (Brown) (4A-4C) observed on exterior walls is confirmed to be an **ACM** Material by initial PLM Method:
 - **222-4A-Siding 1 is 3% Chrysotile**
 - 222-4A-Siding 2 is None Detect
 - **222-4B-NA is 3% Chrysotile**
 - **222-4C-NA is 3% Chrysotile**

The materials assessed were in good condition at the time of the inspection and non-friable.

Non friable in current state however will be rendered friable during demolition. This material will need to be removed prior to any demolition activities.

ACM - Brown

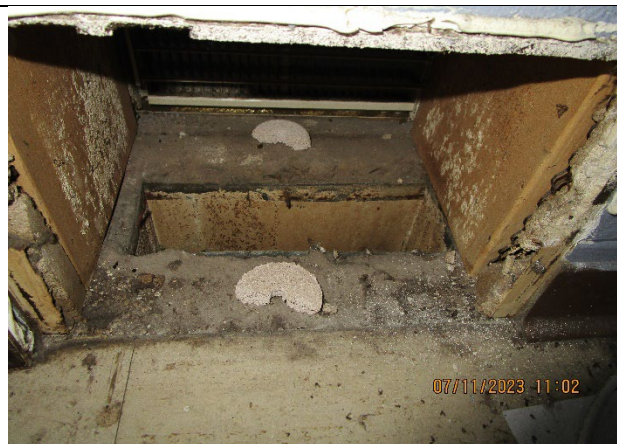
- The structure has multiple layered walls, from past additions.
- The original HVAC runs were installed beneath the concrete floor slab. At the time of 2023 inspection the HVAC runs had been abandoned for 20 + years, according to Sheriff Mobley. APEC did inspect around the floor vent and home runs for possible TSI around joints. No TSI was noted.

HVAC - Floor

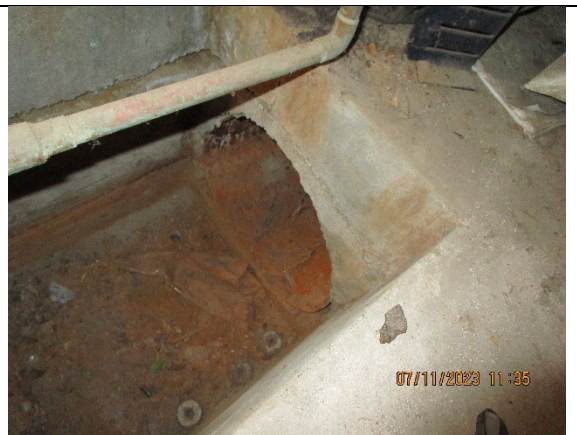
HVAC- Home Run
